CAUSES OF EXTERNAL CORROSION ON COATED AND CATHODICALLY PROTECTED PIPELINES

RICHARD NORSWORTHY
POLYGUARD PRODUCTS, INC.
P.O. Box 755 Ennis, Texas 75120-0755
214-912-9072 or 214-515-5000

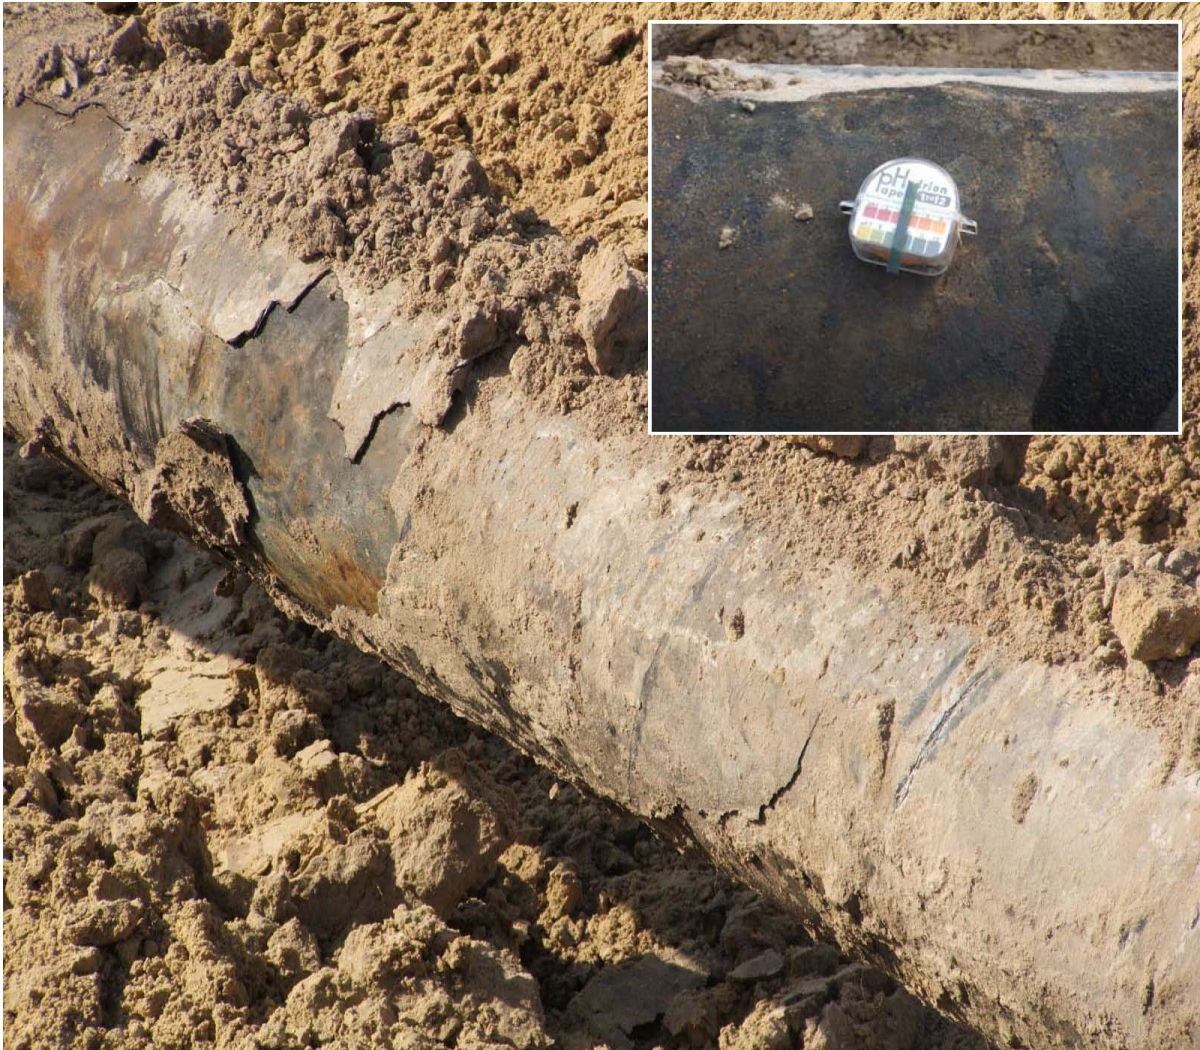
FIGURE #1

Disbonded Coal Tar coating that did not shield the CP current because the coating was deteriorated and cracked enough to allow current through the coating, therefore a high pH and minimal corrosion under the coating.

In this case, the coal tar was deteriorated and disbonded enough that the CP current could be effective. There was corrosion from previous shielding or inadequate CP. See Figure #1.

The cathodic protection “ON” potentials at this site were in a range of -500 mV to -600 mV. Polarized potentials were in the range of -350 mV to -450 mV. Native potentials were in a -200 mV to 300 mV range.

There was no significant corrosion under the disbonded coal tar, with no active corrosion observed. The pH under the coal tar was approximately 10.

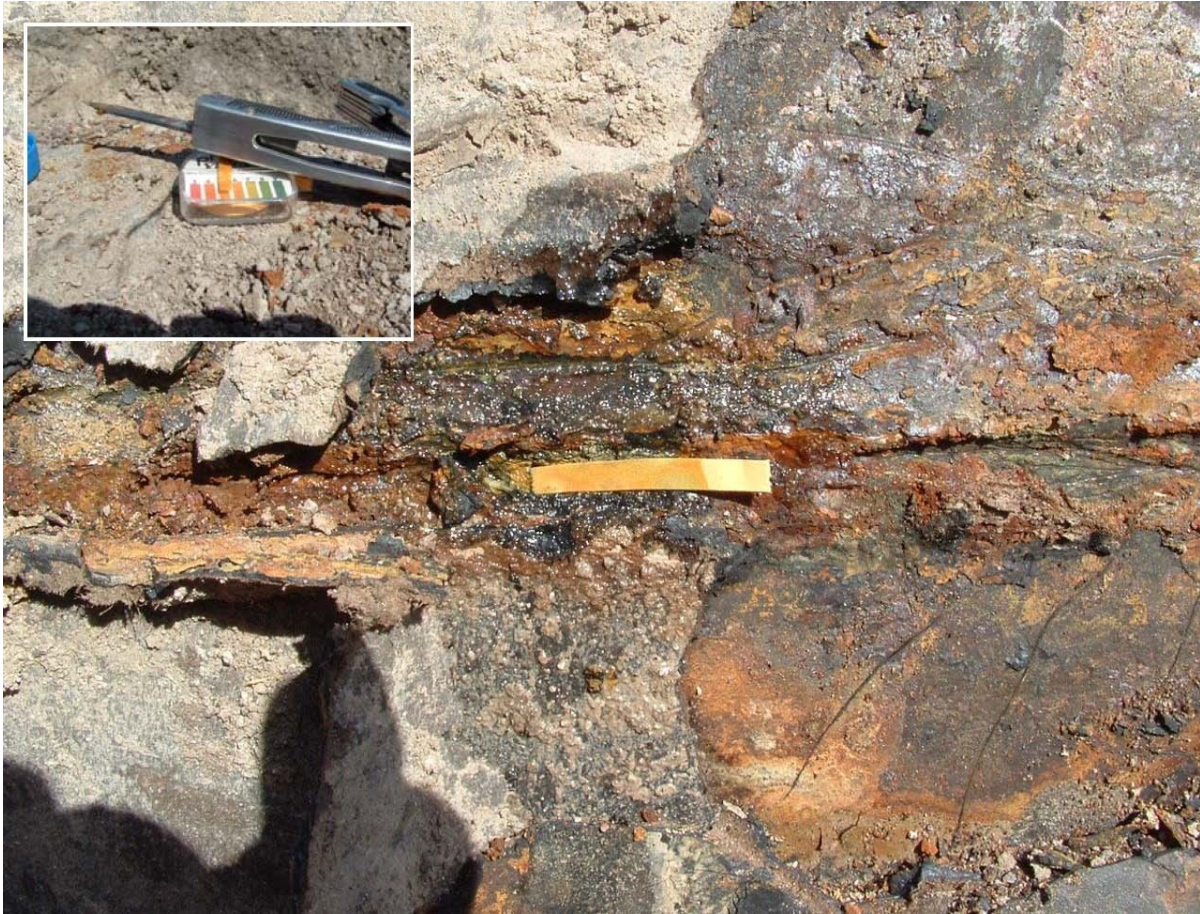
FIGURE #2

Disbonded Coal Tar coating which shielded CP currents.
Significant pitting in this area because of the CP shielding, not lack of CP.

Figure #2 shows the resulting corrosion was active in this area as indicated by the low pH (5) under the coal tar. These are the areas where recoating is recommended since this corrosion will not likely be controlled by CP. Typically, the conventional current will discharge from holidays

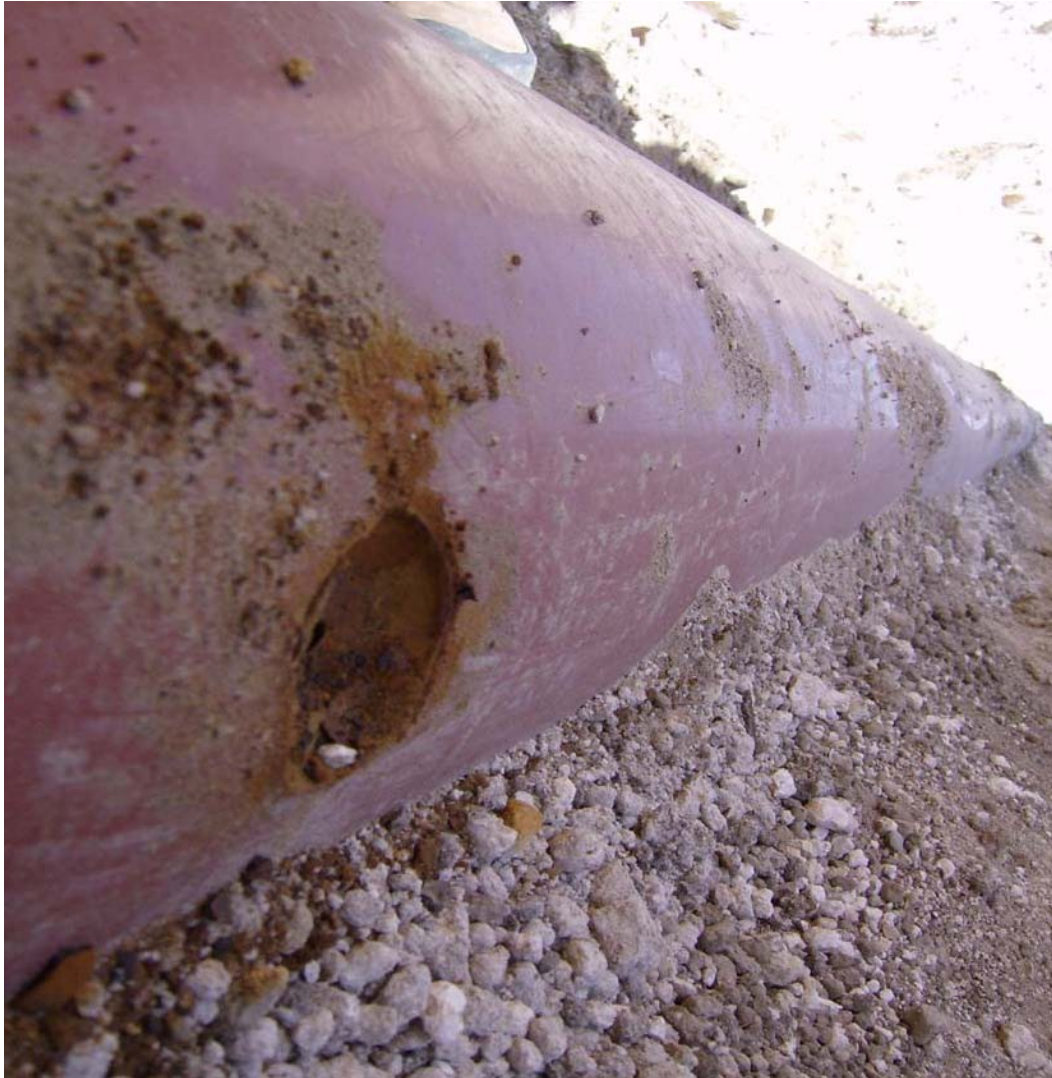
FIGURE #3

Rare external corrosion on FBE coated pipeline caused from DC interference. Corrosion on FBE coated pipeline from shielding of the CP by a large rock on top of the pipe.

Case History #3 shows the damage caused from a DC interference problem. This problem happened when a company installed a new FBE coated pipeline parallel to several other systems that had impressed cathodic protection, but did not properly bond the new pipeline into the CP system. This corrosion occurred in less than one year.

Figure #3 shows the results of such an interference problem. The new FBE coated pipeline was not properly bonded into the existing impressed current CP systems. This corrosion developed in less than one year.

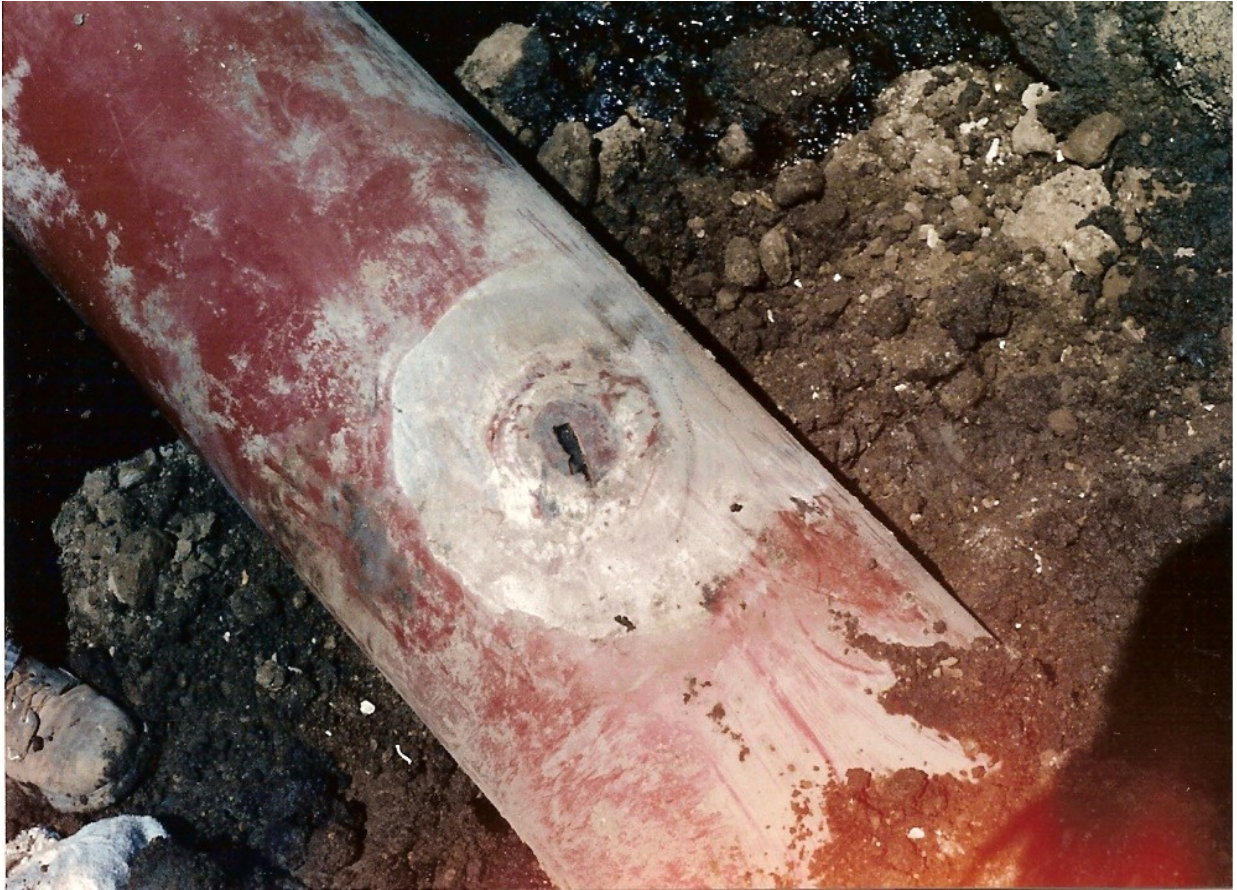
FIGURE #4

Figure #4 shows the results of a large rock setting on top of an FBE coated pipeline shielding the CP. Even though there were other areas that had blistering of the FBE, there was no corrosion because there was no shielding of the CP current by the FBE. The criterion used for this pipeline at this time was an "ON" -850 mV without consideration for IR (except when warranted).

In Case History #4 a rock was removed from the top of an FBE coated pipeline at a corrosion indication from an ILI run. There was corrosion on the pipe under the rock that was

shielding the FBE. Though there was blistering of the FBE in other places on the pipeline, there was no other corrosion located.

The criterion used for this pipeline was an “ON” -850 mV without consideration for IR drop except in areas that indicated a potential problem. The specific potentials for this site are not available. With adequate CP, fusion bonded epoxies (FBE) do not totally shield CP currents^{xiv}; therefore corrosion is not a major problem. However, FBE maintains its electrical insulation properties in the presences of moisture and cathodic protection current.^{xv}

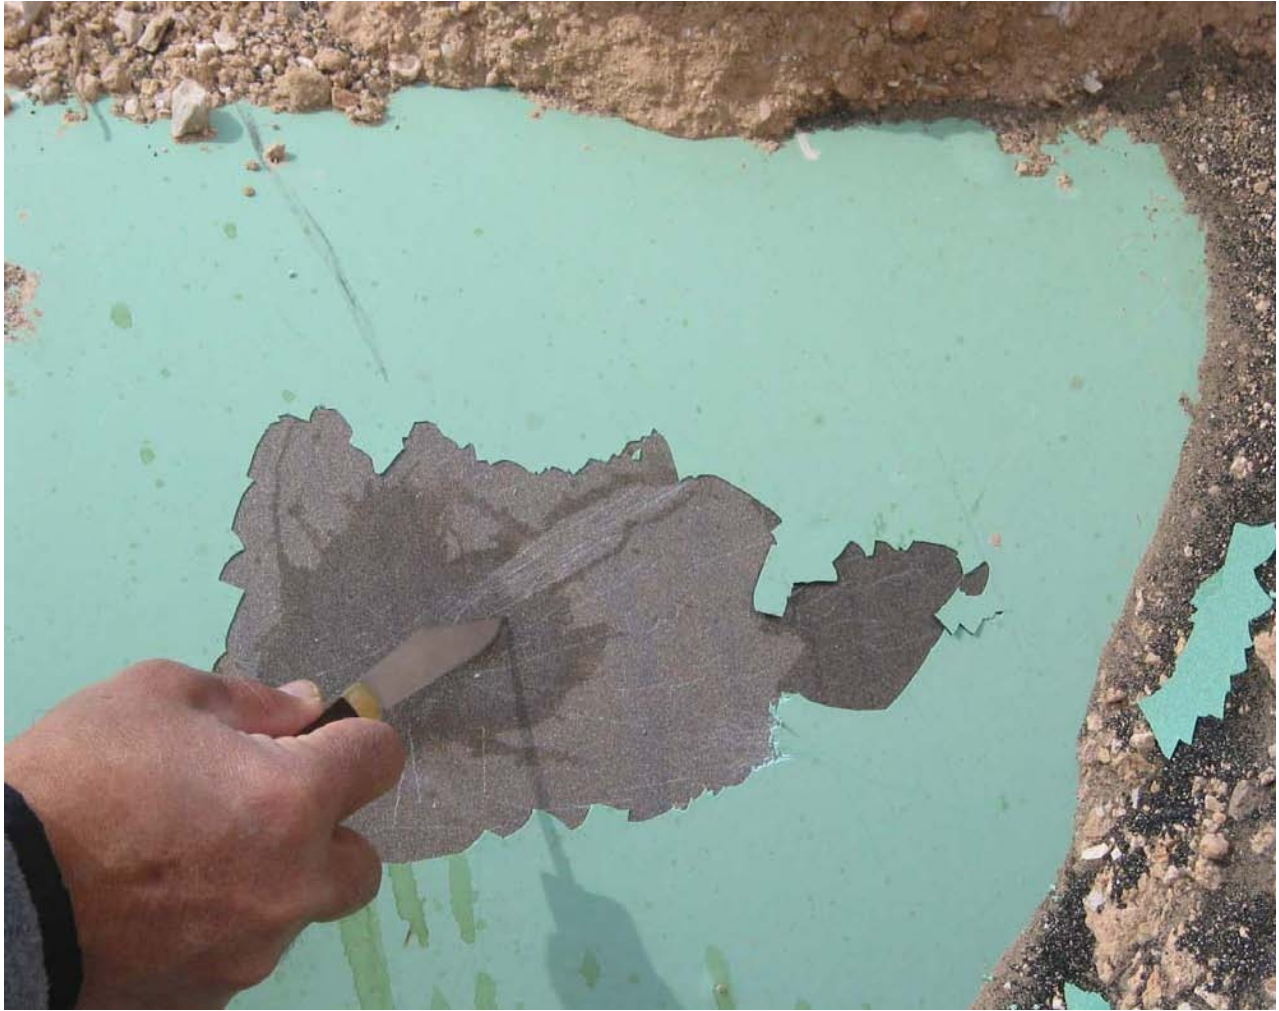
FIGURE #5

Typical results when evaluating disbonded or blistered FBE coating.
The pH of the water under the FBE at this site was 12 indicating that CP currents were not shielded.

Figure #5 shows the typical results when disbonded or blistered FBE is found. The pH is typically from 9 to 12 with little or no corrosion found. Some times the steel is discolored, but with no metal loss.
