# ESTABLISHING compatibility

**Richard Morsworthy, Lone Star Corrosion Services, Polyguard Products Inc., USA,** argues the importance of understanding how pipeline coatings work in conjunction with cathodic protection.

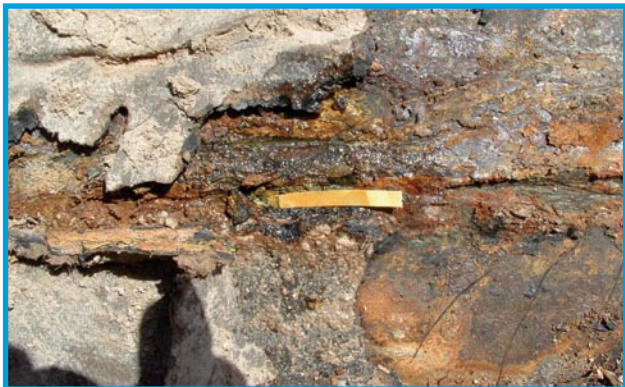
**Figure 1.** pH of 5 under disbonded coal tar coating with significant corrosion present (not 'fail safe').

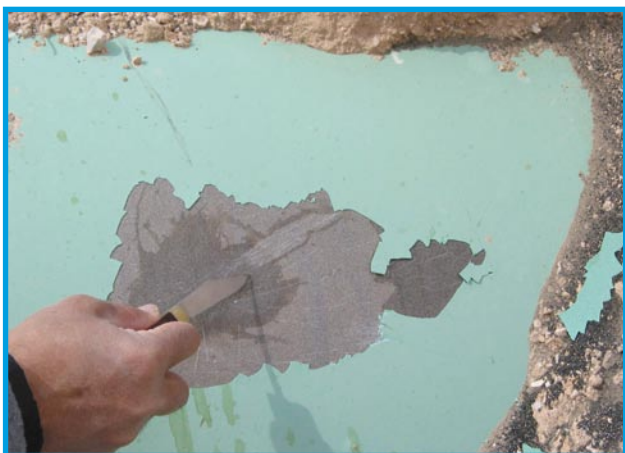
**Figure 2.** Even though blisters and poor adhesion were a problem, the steel under the FBE coating shows to be in excellent condition, proving 'fail safe' properties.

No claim is made that these two coating systems are 100% 'fail safe' in all conditions, but field and laboratory results have proven this characteristic does exist.<sup>12</sup> FBE has been used for approximately 40 years. In that time there have been numerous FBE failures reported, analysed and researched, yet it has been very rare to find corrosion or Stress Corrosion Cracking (SCC). However, the electrical resistance is low enough to allow cathodic protection to prevent corrosion on the pipe with disbonded or blistering coating - FBE is non-shielding.<sup>13</sup> Usually there is a high pH of any water under the FBE, indicating CP current is actually penetrating the FBE to provide adequate protection to the pipe.
