(PROVEN PROTECTION)

Richard Norsworthy and Chic Hughes, Polyguard Products Inc., USA, outline the obstacles to effective coating performance and the company's innovative solutions to these problems.

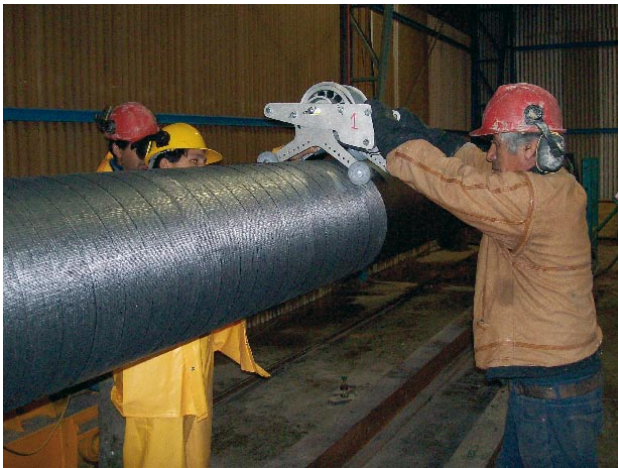
Figure 1. Plant application of Polyguard RD-6 in Chile.

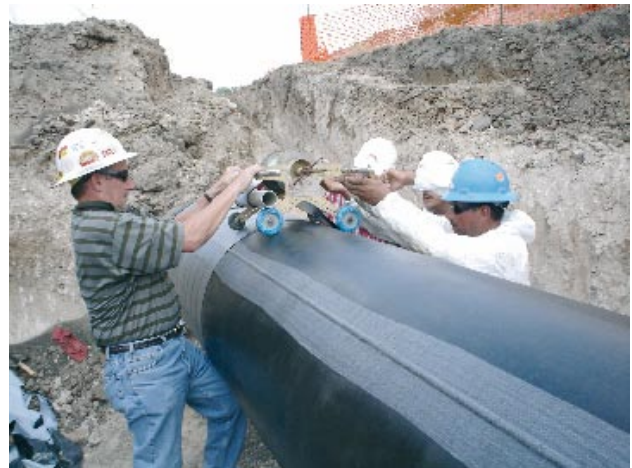
Figure 3. Field application of the RD-6 coating system on a 30 in. rehabilitation project in South Texas.

In the early 1990s, several recoat projects on 30 in. and 36 in. natural gas lines were carried out in South Texas. This area is known for severe soil stress problems. One section was uncovered after several years on the 36 in. line, with no wrinkling or disbondment from soil stress. Many other major and minor rehabilitation projects have been completed since this time.

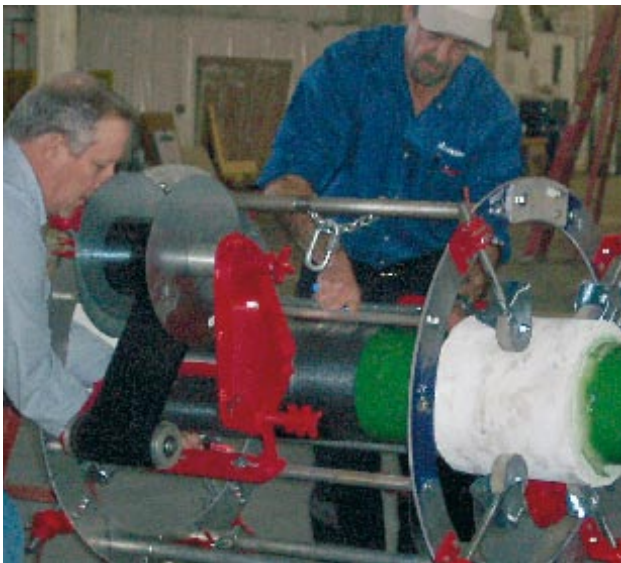
Figure 2. Demonstration of offshore applicator. Typical application takes less than two minutes.

Polyguard has now developed a coating system for offshore application on lay barges that is very fast and provides 'non-shielding' properties. The RD-6 OS has been tested to ensure it will not be damaged by the hot foam infill materials used to fill the space left at the girth weld areas on concrete weight coated pipelines used in offshore construction.
