Paper No.  
**09043**

# COATINGS USED IN CONJUNCTION WITH CATHODIC PROTECTION – SHIELDING VS NON-SHIELDING PIPELINE COATINGS

Richard Norsworthy  
Polyguard Products, Inc.  
Ennis, Texas 75120  
214-912-9072 or  
214-515-5000

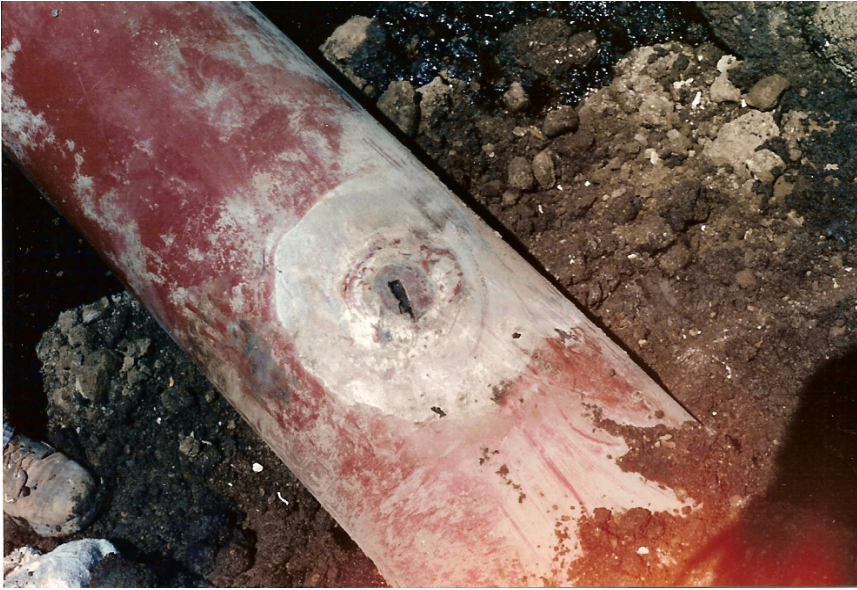
Photo #1 - 12" diameter pipe with corrosion on FBE coated pipe. This pipe had a large boulder setting on top of the pipe shielding CP.

Though rare, corrosion has been found on FBE coated pipelines. A significant pit was found at the 12:00 o'clock position from an internal line inspection tool run in 1992. When the area was excavated a very large boulder (1 to 2 tons) was removed from the top of the pipe. There were several blisters in the FBE coating in this area. The one pit was directly under the boulder which had apparently shielded the CP from the pipe. No corrosion was found under any of the other blistered FBE in the area proving the typical non-shielding properties of FBE. See Photo #1.

The pipe was a 12” diameter coated with 22 mils of FBE and had been in service since the early 1980’s. The operating temperature was approximately 180° F. The “On”

potential was -1160 mVcse and the criterion used on this pipeline was an “ON” -850 mV. There was also a large waste management pond just above the pipeline and there were significant bacteria in the water around the pipe. A variety of coating systems had been used on the pipelines in this area, but these coatings (extruded polyethylene, solid film backed tapes and coal tars) all failed because of the heat, allowed water into the space between the solid film coatings which shielded the CP allowing corrosion to happen.

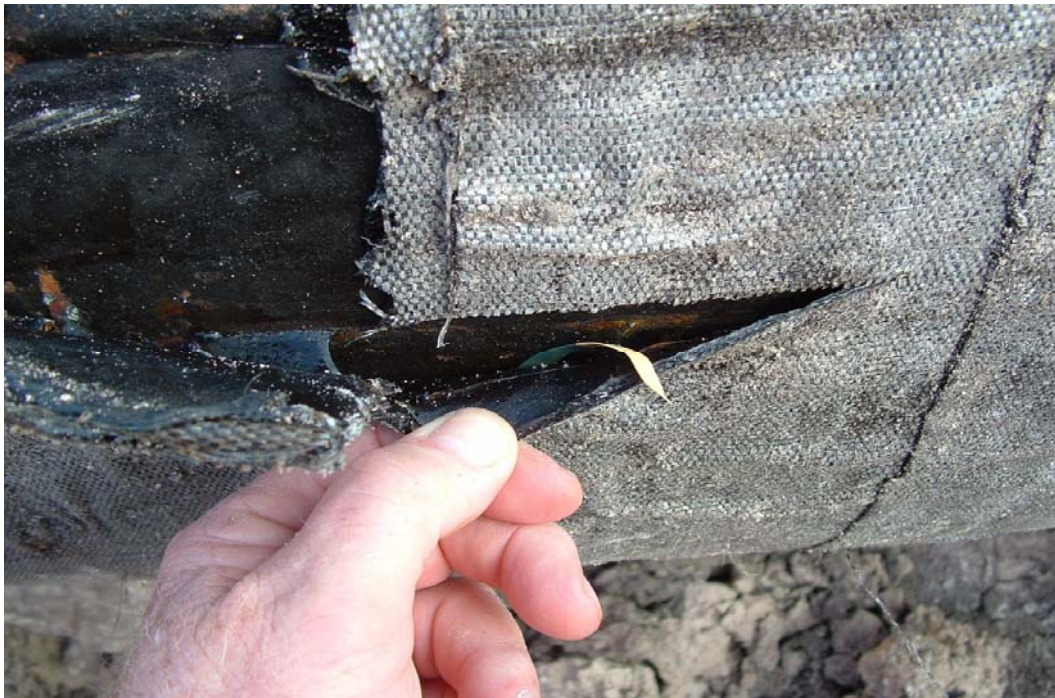
Photo # 2 – Checking pH under disbonded, non-shielding geo-textile mesh backed coating system. pH was approximately 10, proving non-shielding properties.

The geo-textile mesh backed coating mentioned above has rarely had a known failure. One pipe coated with this coating was excavated after three years of service life had minor wrinkling and water between the coating and pipe. The coating was applied in a severe soil stress area without proper tension, without outer wrap, without stripping of the weld seams, incomplete primer application and applied over disbonded coal tar allowing water to migrate along the weld seam under the mesh backed tape coating. There was no significant corrosion or metal loss. The pH of the water under the coating was 10, proving this coating is truly compatible with CP if there is disbondment and water penetration. See Photo #2.

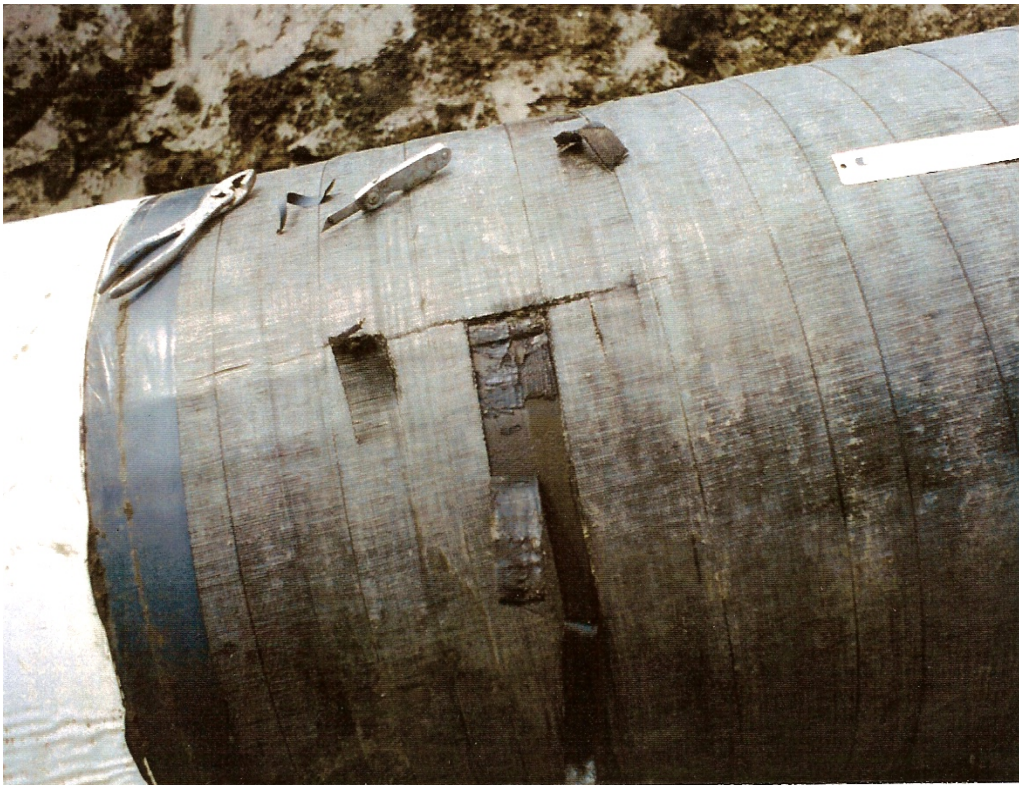
Photo #3 – Geo-textile mesh backed coating system applied to a partially wet pipe surface. No adhesion on wetted surfaces, but very good in other areas. After three years water under coating had a pH of 11, proving non-shielding.

A test area on a 30" natural gas pipeline was excavated and several coatings were applied for a test. The geo-textile mesh backed tape was chosen for this testing. The sunny side of the pipe was dry, but the shady side had condensation. The decision was made to coat the pipe with it partially wet to see the results when exposed. The site was excavated after three years of service. As expected, the coating did not bond to the wet surface, but was well bonded to the dry side of the pipe. The area that was wet had a pH of 11 under the pipeline coating, again proving this coating allows CP to work even if adhesion is lost and water penetrates. See Photo #3.

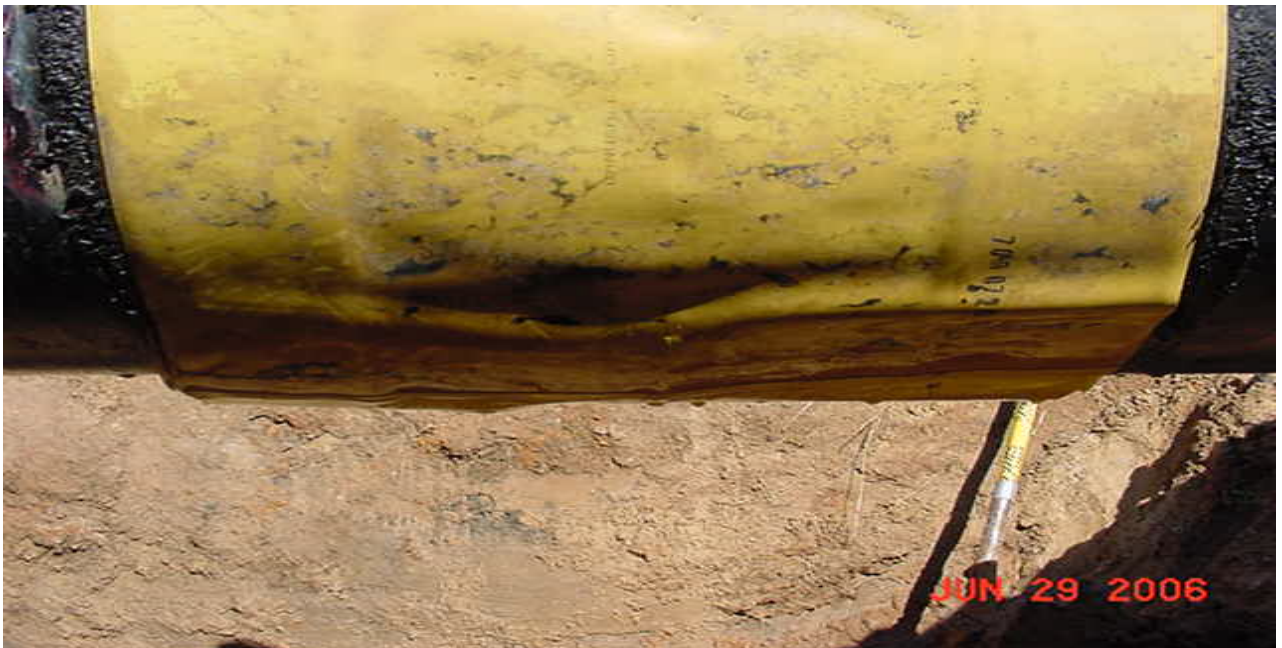
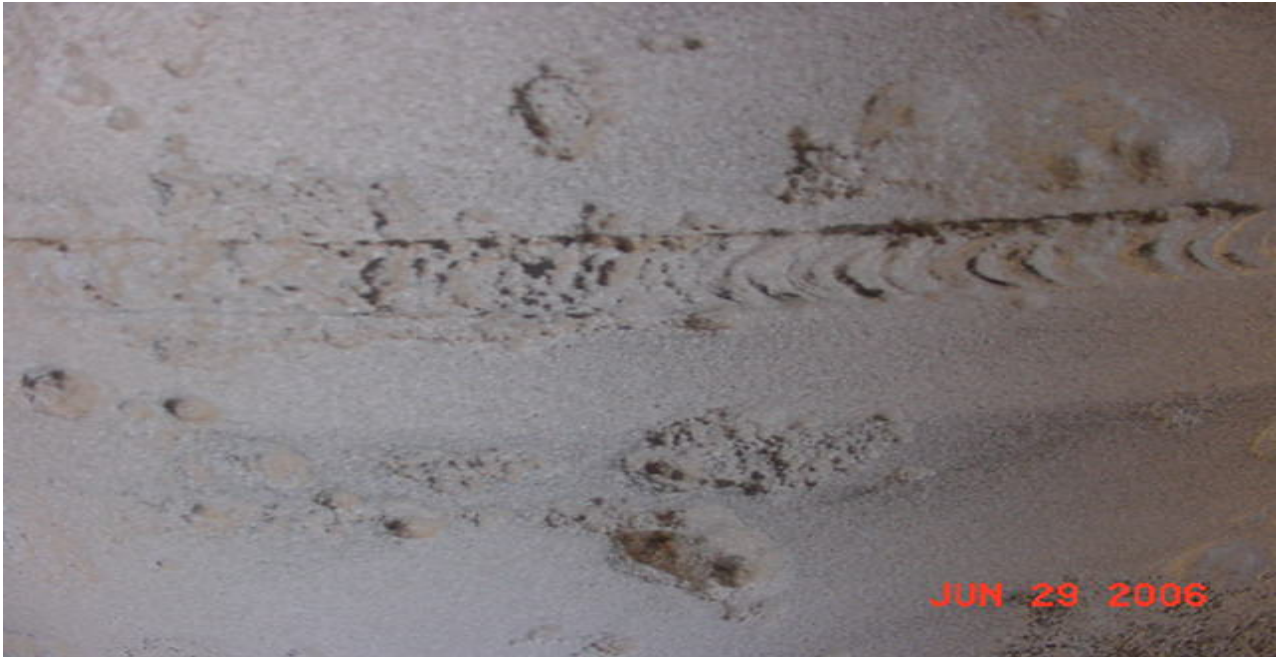
Photo #4 - Shrink sleeve applied in 1997 and resulting corrosion found in 2006. Shrink sleeve shielded the CP. Pipe potentials met all NACE criteria.

Shrink sleeves were applied to a 10" pipe as the girth weld coating. The main body of the pipe was plant coated FBE. An ILI was run nine years later to inspect for possible problems. Corrosion was found only at the girth welds under shrink sleeves that had wrinkled from soil stress and possible poor application practices. Significant corrosion was found under some sleeves requiring exposing the pipe and replacing the coating.
